Surface Treatment Improvements Will Save Costs and Extend Service Life for CVN Elevator Support Structures

PROBLEM / OBJECTIVE

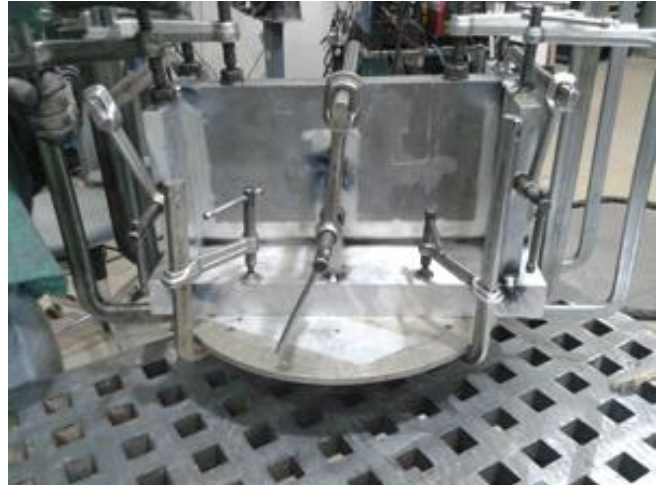
Implementing methods to prevent or delay the onset of cracks on CVN elevator structures will avoid costly repairs and down time. NMC photo

The Integrated Project Team examined three different treatment methods: weld buttering, ultrasonic impact treatment (UIT), and thermal spray coating. Treatments were applied to test weldments (illustrated at right) and then evaluated for residual stress and corrosion performance. Analysis of the test results revealed that either UIT with thermal spray or weld buttering were acceptable methods to prevent stress corrosion cracking on the aircraft carrier elevators. UIT alone was not an acceptable treatment.
