Plate Size, Residual Stress and Plasma Cutting Practice Effects on HSLA-80 Cut Part Distortion

Status: Implemented

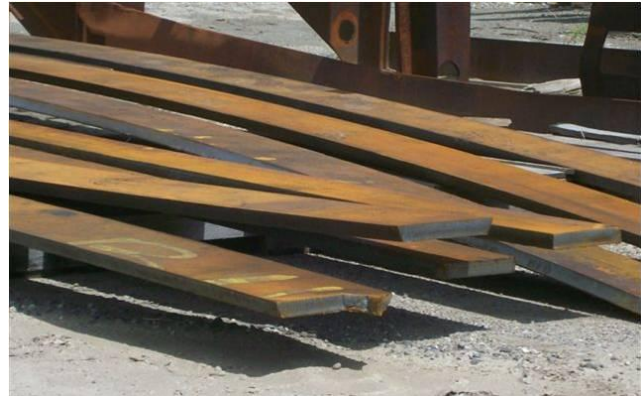
CTC reference photo. Random cut part distortion

When Bath Iron Works (BIW) performed plasma cutting of HSLA-80 plates for DDG 1000 construction, significant distortion occurred, which resulted in excessive rework to mechanically flatten cut shapes. Cutting the distorted plates also led to significant downtime and damage to the plasma cutting equipment. Limited trial cutting results at BIW indicated that plate distortion was more a function of plate residual stresses than thermal distortion due to plasma cutting. The Navy Metalworking Center (NMC) assisted BIW in determining the root causes of HSLA-80 plate distortion experienced during plasma cutting and whether revisions need to be made to future procurement specifications for HSLA-80 plate in order to minimize distortion issues.
