# Improved Installation Procedures to Reduce Cost of Aircraft Carrier Transparent Armor Windows

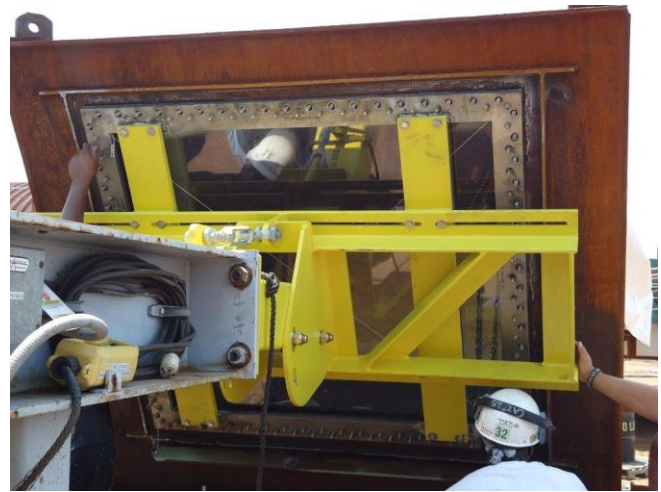
New fixture and process will improve TA window installation on aircraft carriers. NNS Photo

The prototype fixture and associated procedures developed in this project will hold the window in place and enable uniform torquing of the mounting bolts, thereby reducing the potential for residual stresses that may result from the installation process itself.
