Preventing Coating Damage from Welds Will Reduce New Construction Cost

PROBLEM / OBJECTIVE

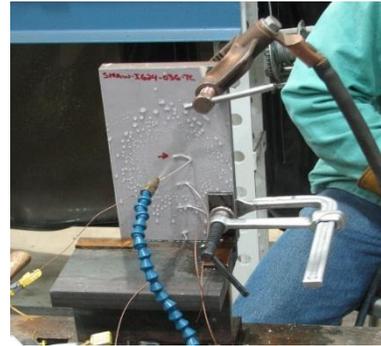
Cooling-assisted welding will prevent coating damage on the back side of plates and tank walls. NMC photo.

The NMC project identified the effects of stud arc and shielded metal arc welding on typical attachment and wall thickness combinations with two standard Navy coating systems. Project test results demonstrated that two cooling methods can be used effectively to prevent welding-induced damage to coatings for many of the attachment and wall thickness combinations.

The project's weld test data with unassisted cooling confirms that the removal of certain evaluated coating systems from the back side of a structure will no longer be necessary for certain combinations of attachment size and wall thickness. Evaluation of the cooling-assisted weld test data concluded that welding parameter combinations that would normally cause coating damage can be prevented with the use of assisted cooling, thus eliminating the labor costs associated with coating rework.
